Water Resources Technical Report

183A Phase III from Hero Way to 1.1 miles
North of State Highway 29

Leander, Williamson County, Texas

CSJ: 0914-05-192

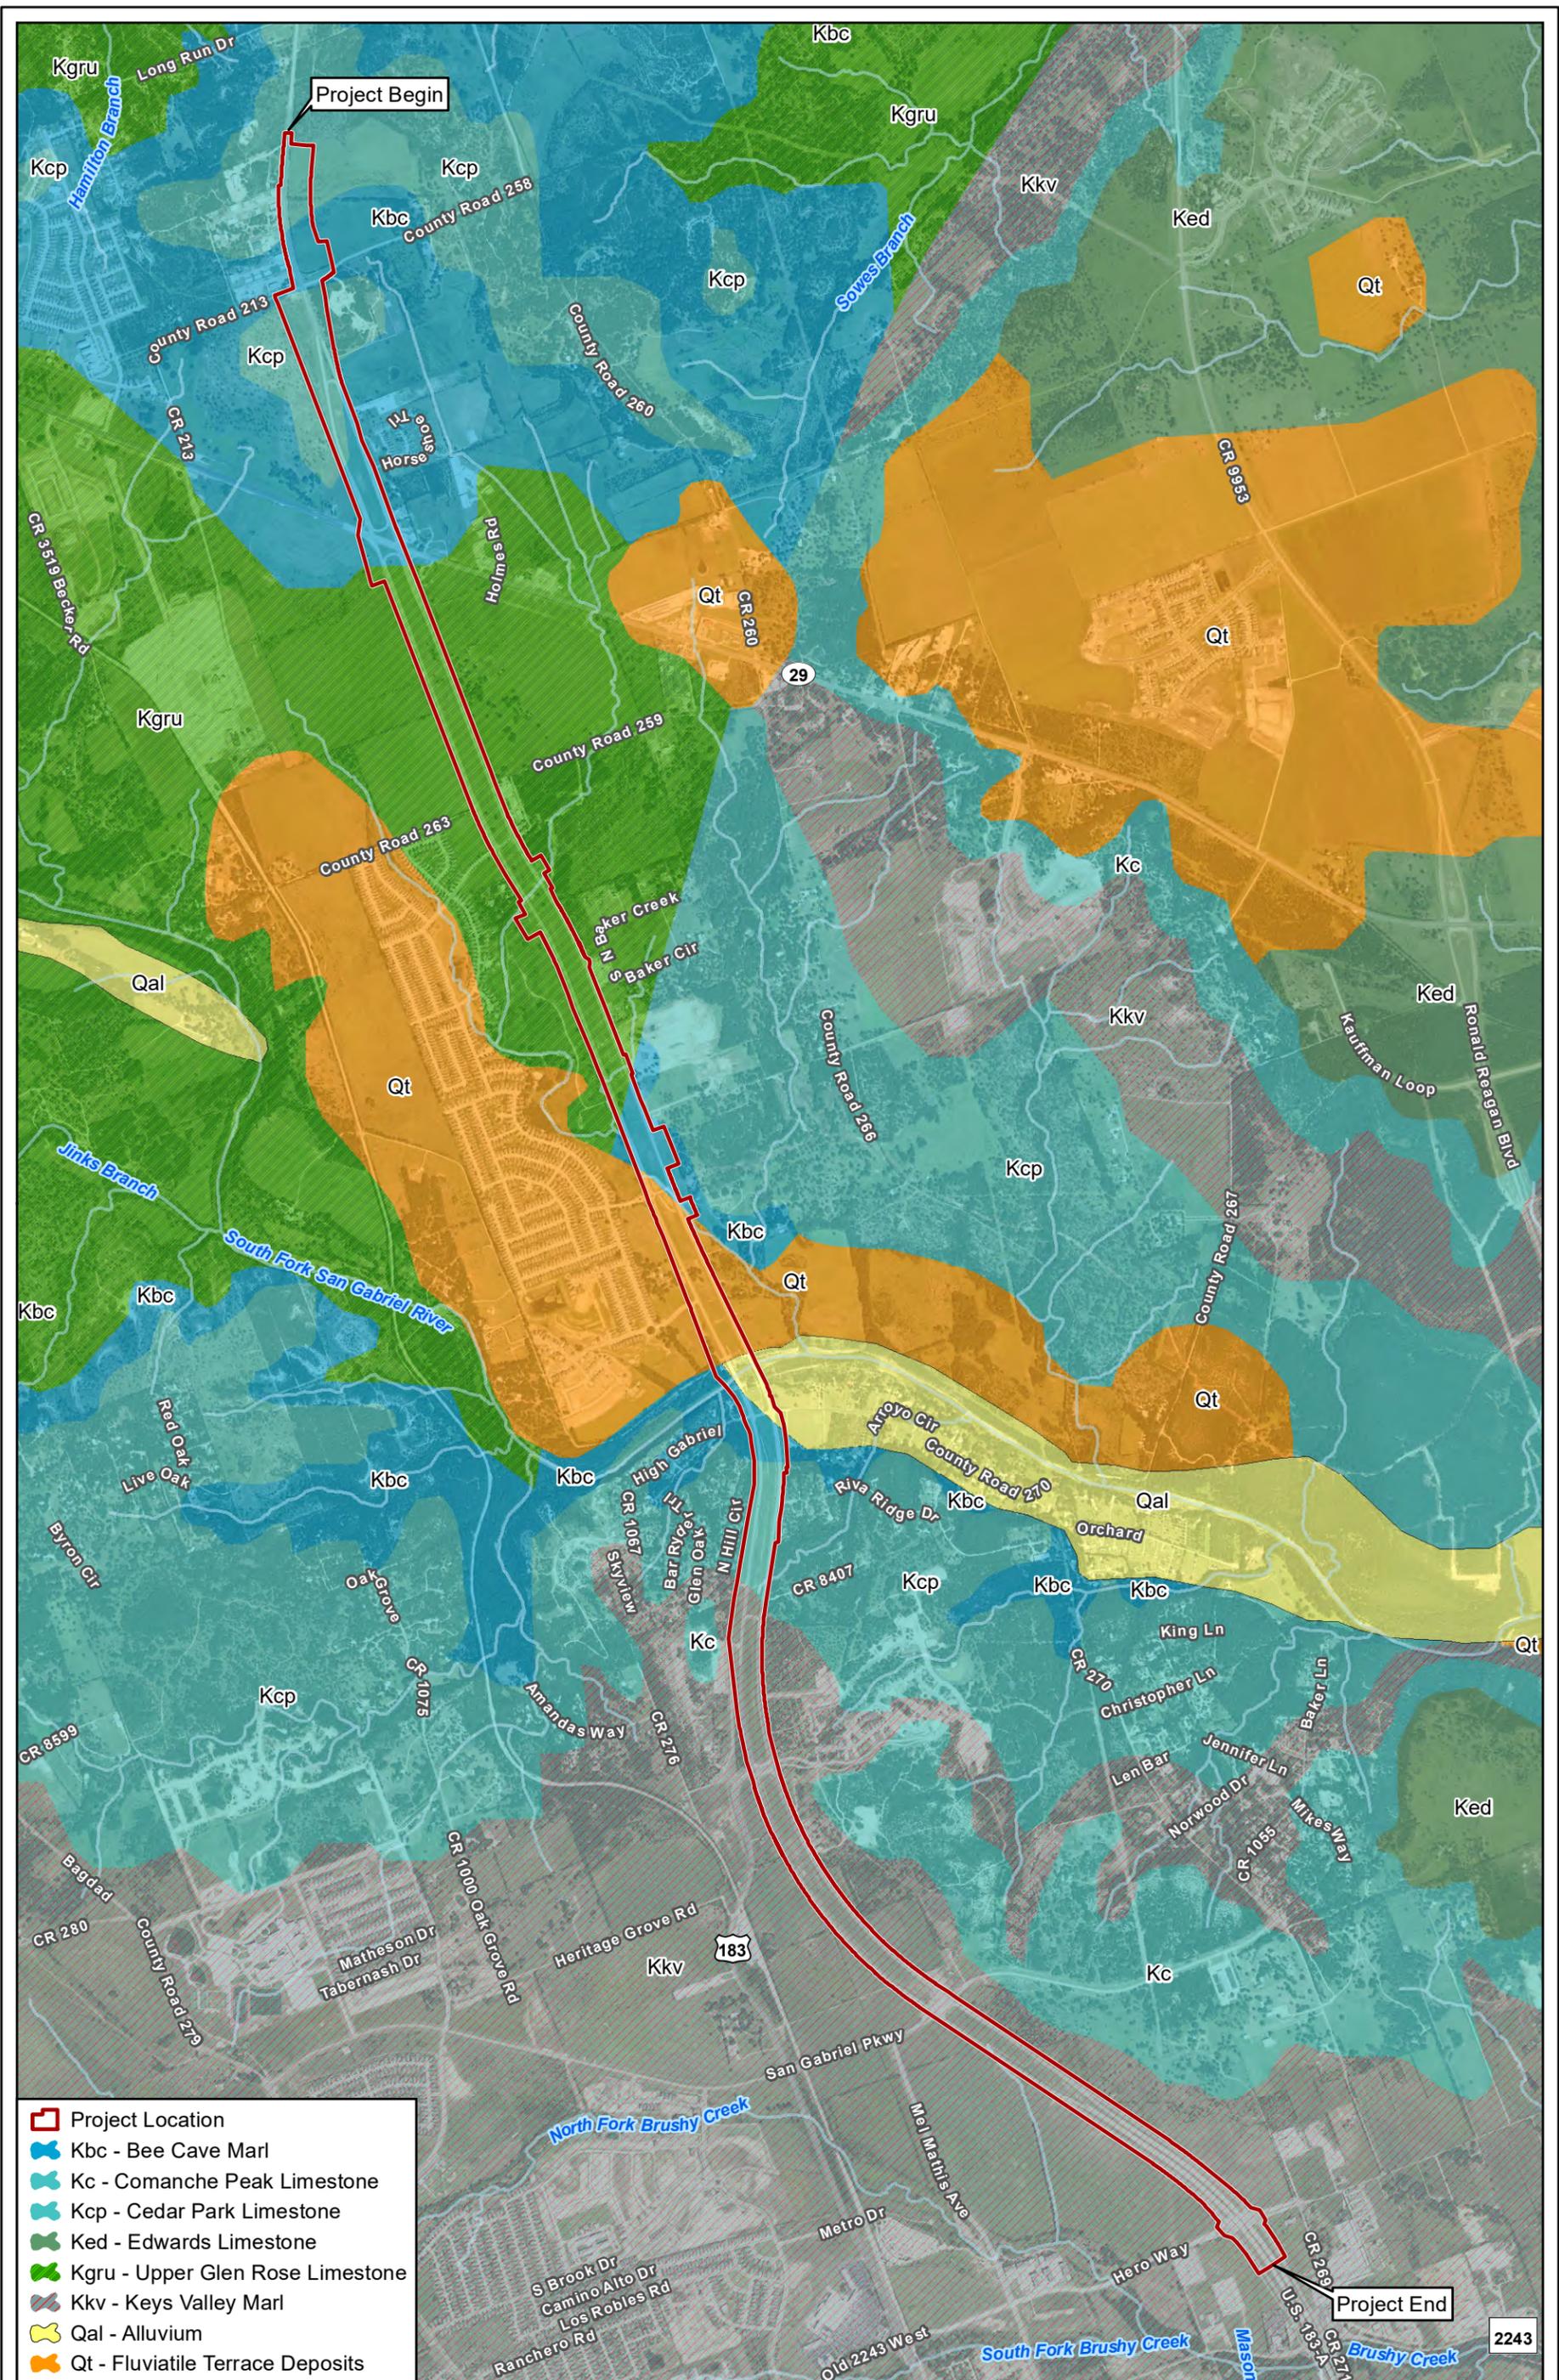
- ▭ Project Location
- Kbc - Bee Cave Marl
- Kc - Comanche Peak Limestone
- Kcp - Cedar Park Limestone
- Ked - Edwards Limestone
- Kgru - Upper Glen Rose Limestone
- Kkv - Keys Valley Marl
- Qal - Alluvium
- Qt - Fluvial Terrace Deposits

Figure 3
Project Area Geology
183A Phase III

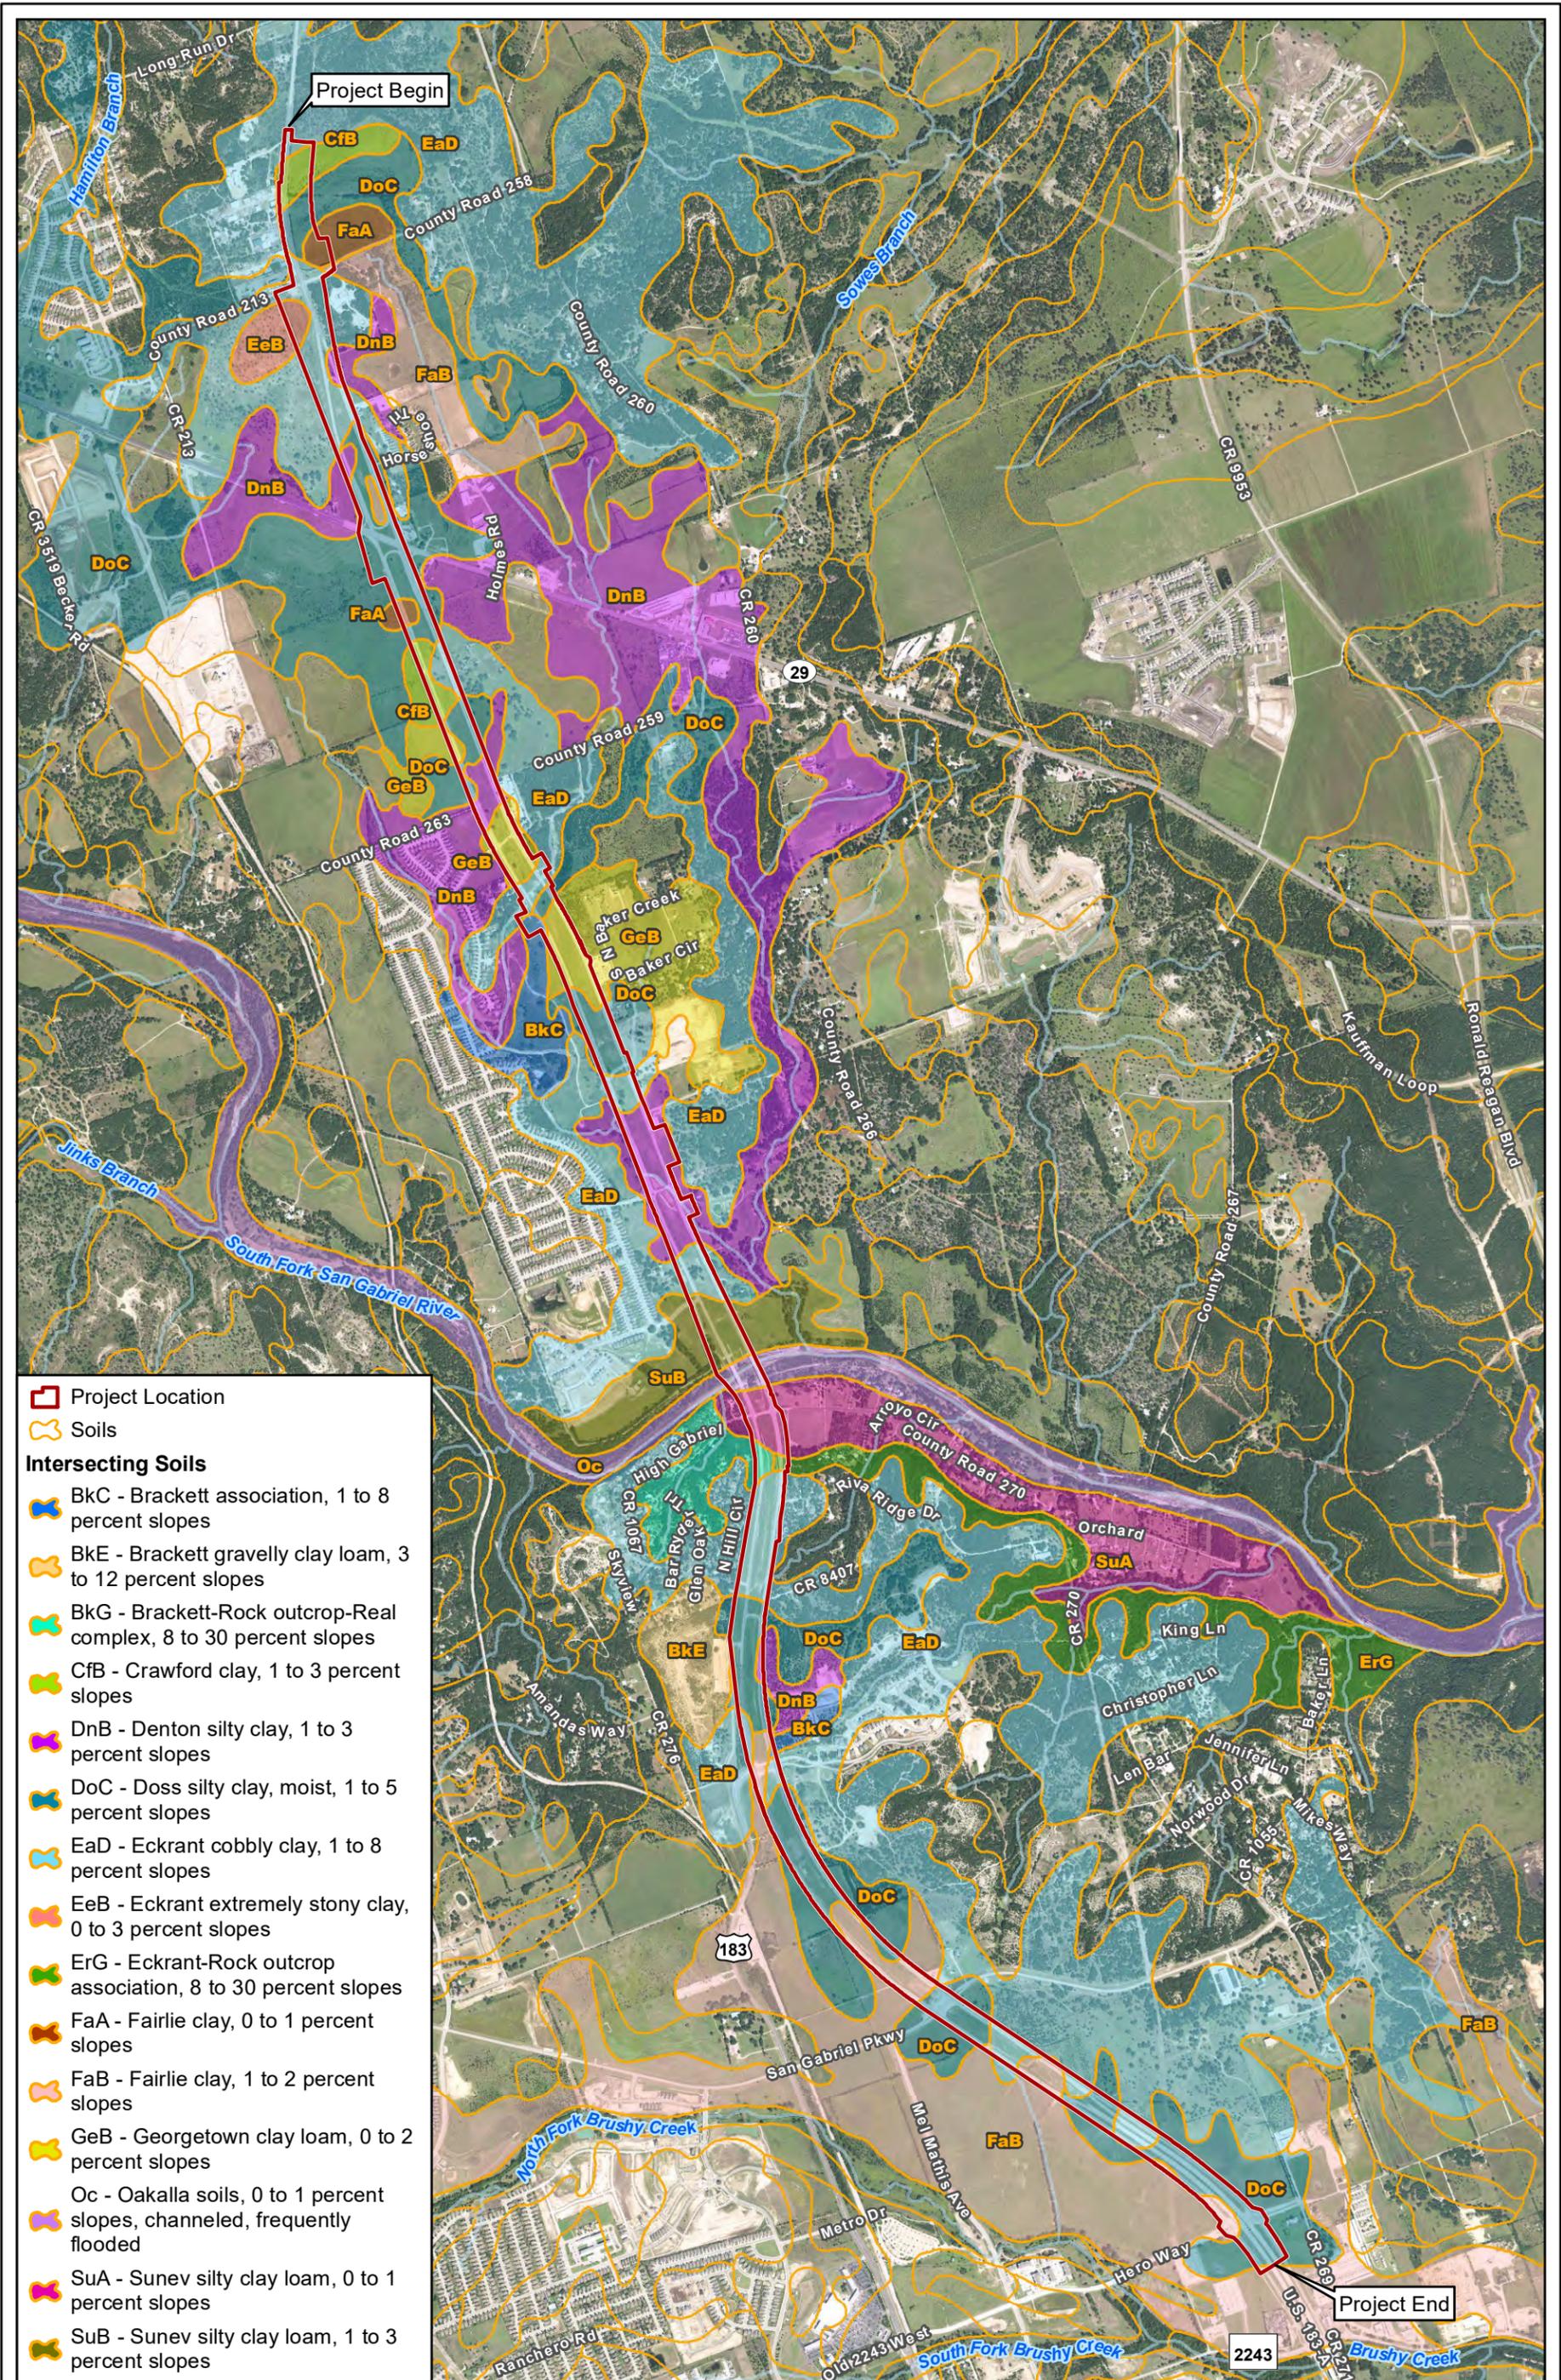
- ▭ Project Location
- Soils
- Intersecting Soils**
- BkC - Brackett association, 1 to 8 percent slopes
- BkE - Brackett gravelly clay loam, 3 to 12 percent slopes
- BkG - Brackett-Rock outcrop-Real complex, 8 to 30 percent slopes
- CfB - Crawford clay, 1 to 3 percent slopes
- DnB - Denton silty clay, 1 to 3 percent slopes
- DoC - Doss silty clay, moist, 1 to 5 percent slopes
- EaD - Eckrant cobbly clay, 1 to 8 percent slopes
- EeB - Eckrant extremely stony clay, 0 to 3 percent slopes
- ErG - Eckrant-Rock outcrop association, 8 to 30 percent slopes
- FaA - Fairlie clay, 0 to 1 percent slopes
- FaB - Fairlie clay, 1 to 2 percent slopes
- GeB - Georgetown clay loam, 0 to 2 percent slopes
- Oc - Oakalla soils, 0 to 1 percent slopes, channeled, frequently flooded
- SuA - Sunev silty clay loam, 0 to 1 percent slopes
- SuB - Sunev silty clay loam, 1 to 3 percent slopes

Figure 4
Project Area Soils
 183A Phase III

According to Natural Resources Conservation Service (NRCS) Web Soil Survey, the project area transects 15 soil map units, which exhibit a range of slopes and infiltration characteristics (**Figure 4**). One soil map unit, Oakalla silty clay loam, 0 to 1 percent slopes, channeled, frequently flooded, is listed as containing hydric inclusions. A list of soils occurring within the project area is summarized in **Table 1**.

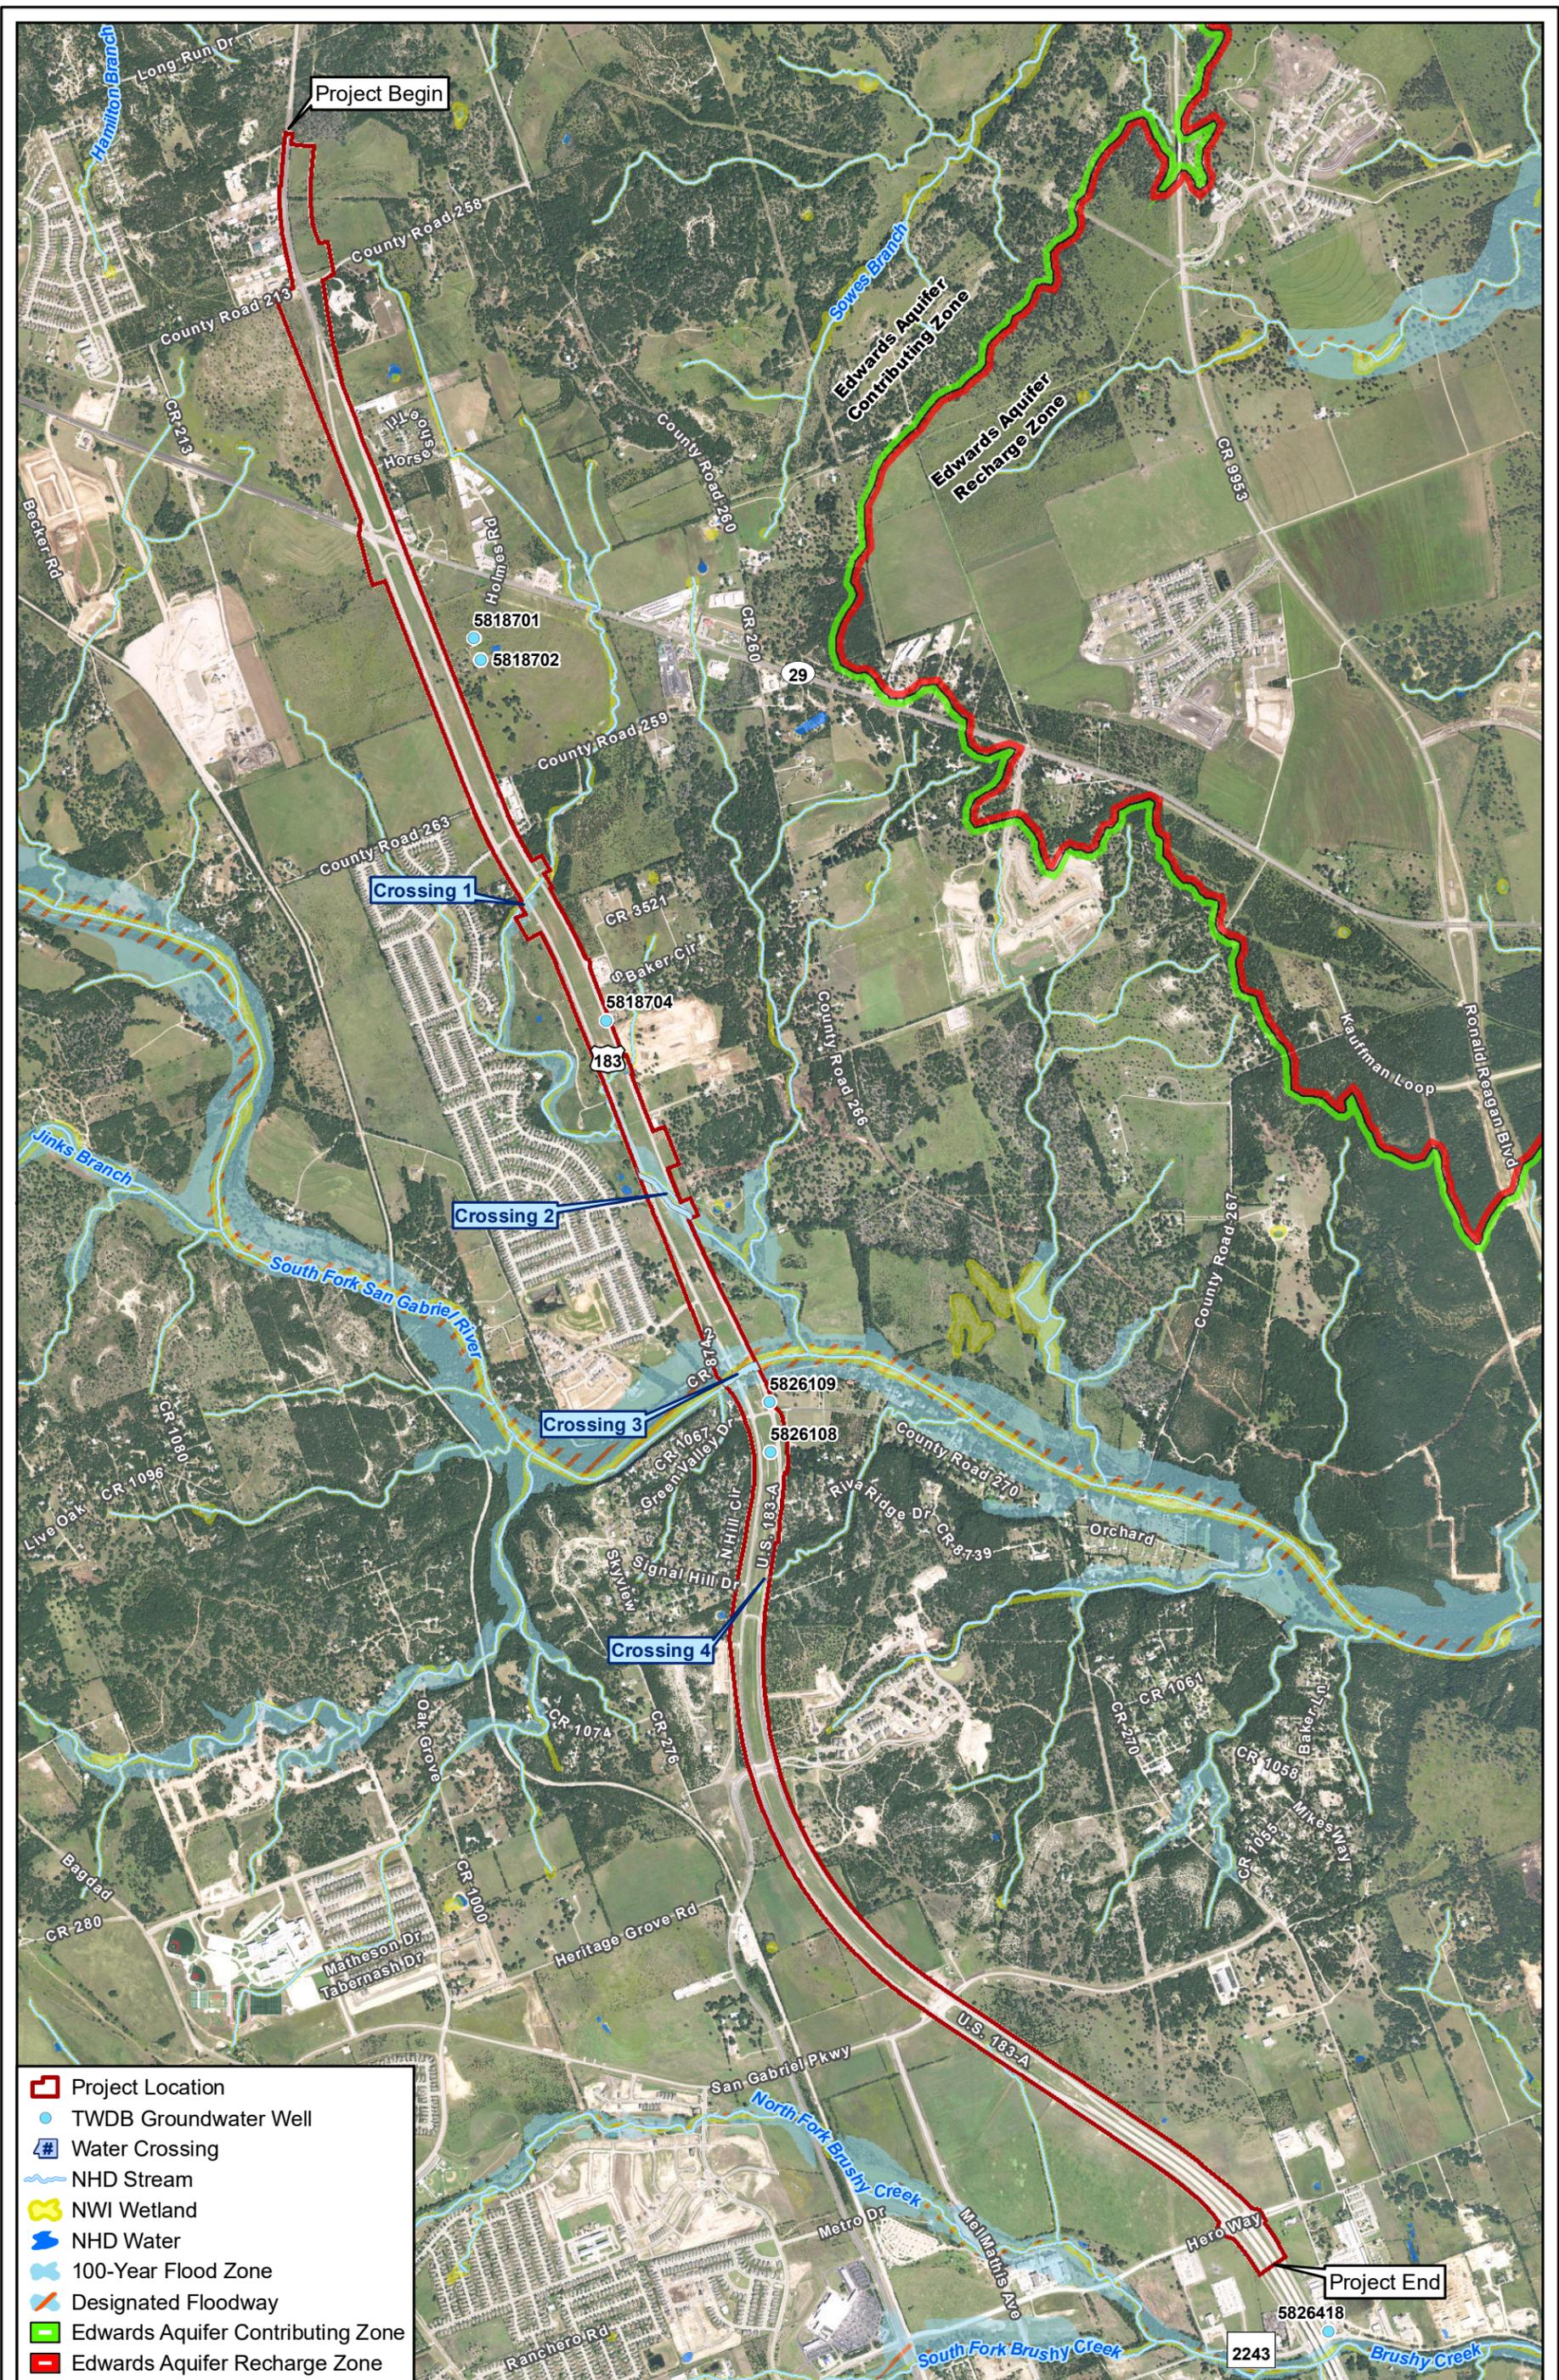
- ▭ Project Location
- TWDB Groundwater Well
- - - Water Crossing
- ~ NHD Stream
- NWI Wetland
- NHD Water
- 100-Year Flood Zone
- - - Designated Floodway
- Edwards Aquifer Contributing Zone
- Edwards Aquifer Recharge Zone

Figure 5
Water Resources
 183A Phase III

According to the TxDOT-TCEQ 2013 MOU, the project would require coordination with the TCEQ because the project is classified as an Environmental Assessment and is located within the boundary of the Edwards Aquifer Zones. BMPs for limiting impacts to water quality in the project area will be developed once an alternative has been selected. BMPs can include both permanent controls such as stormwater detention ponds, vegetative filter strips, and hazardous material traps and temporary controls such as silt fencing and dust abatement. BMPs are used to limit the amount of sediment entering the surface water and groundwater from the project area during the construction and operational phases.

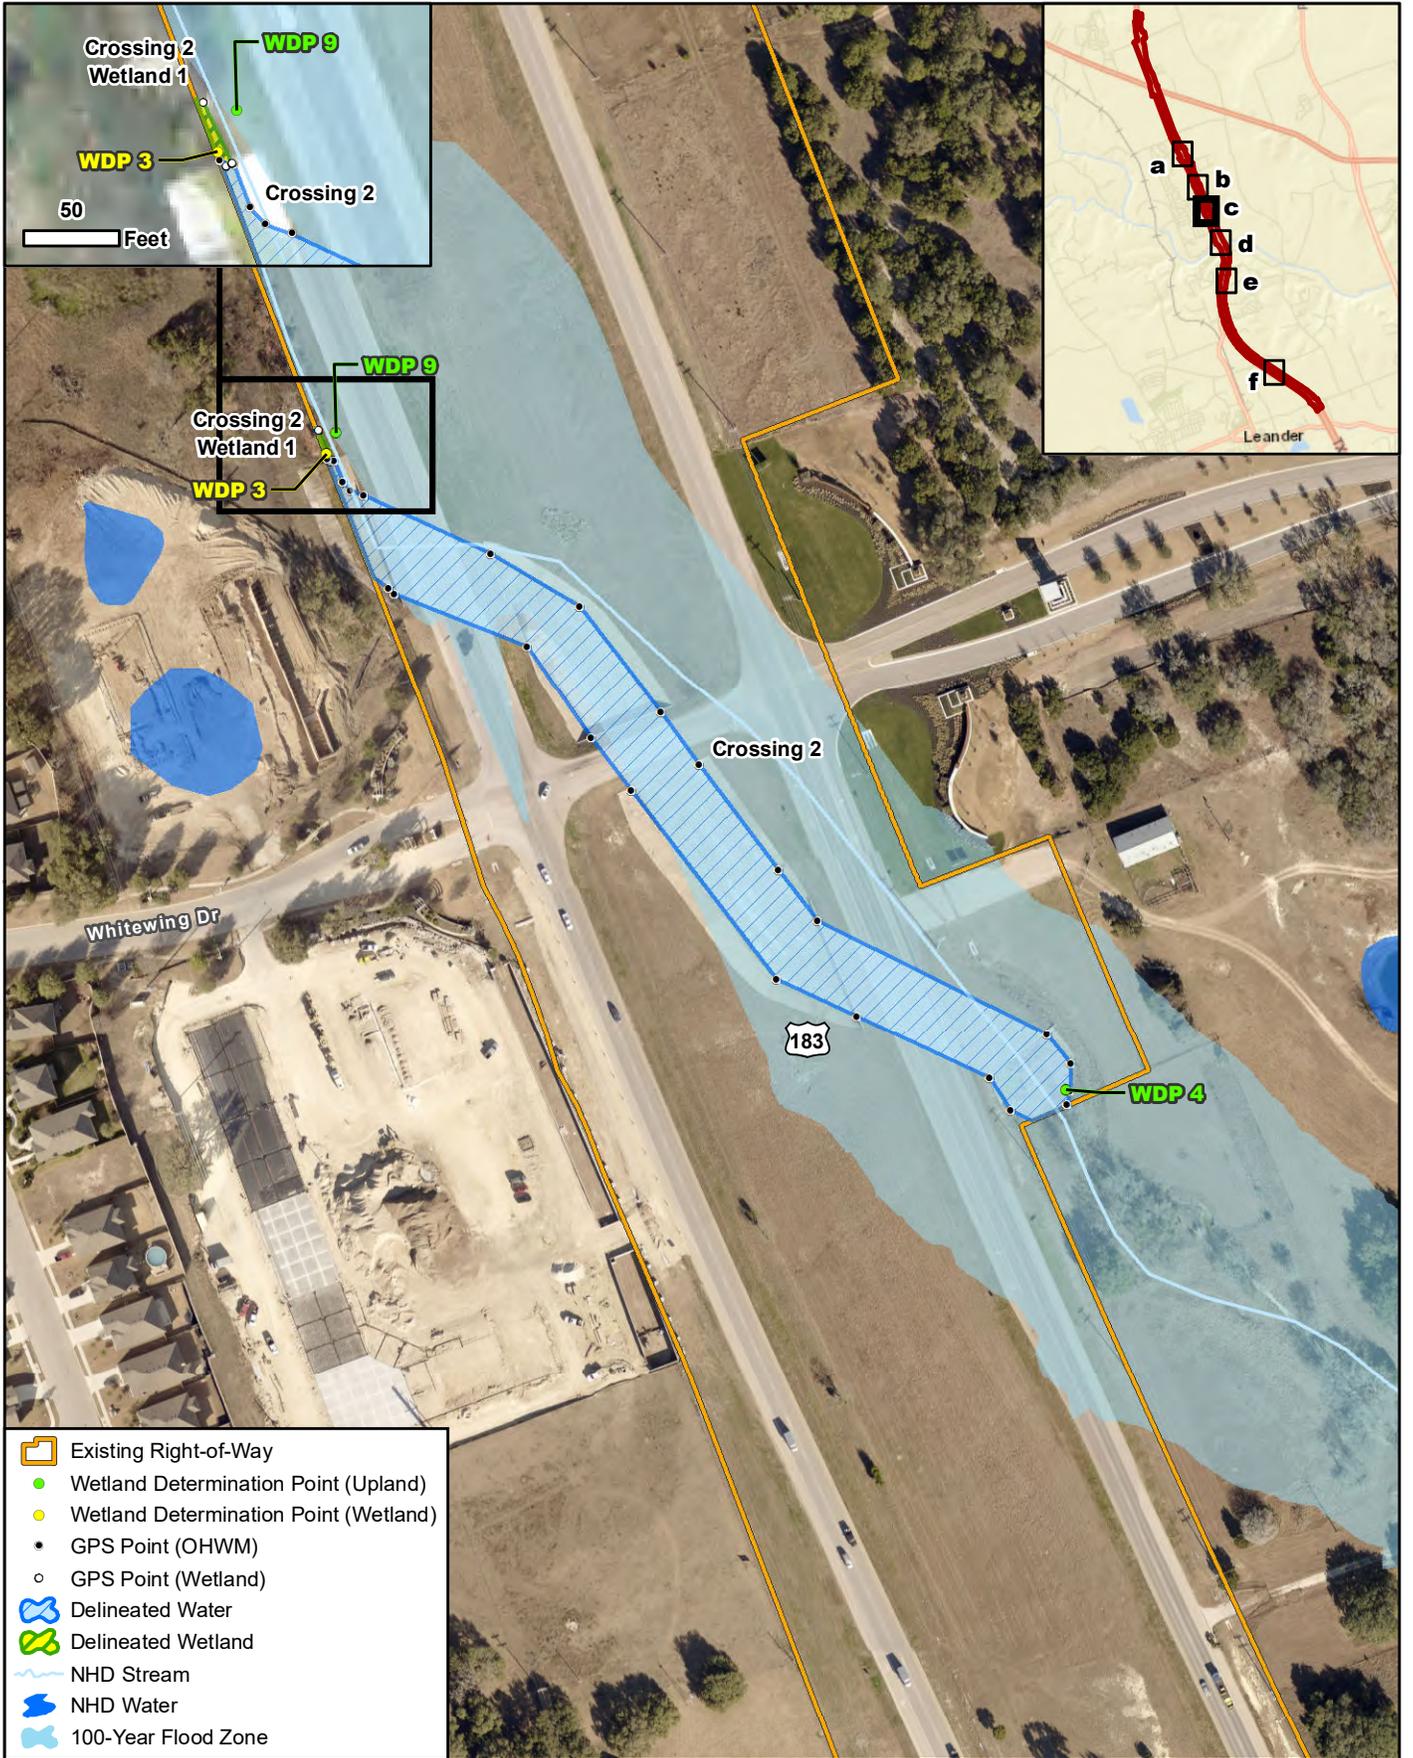
Figure 6c
Potential Waters of the U.S.
183A Phase III

Crossing 2 is composed of a tributary to the South Fork of the San Gabriel River and an adjacent wetland. Crossing 2 is depicted on USGS maps and on NWI maps as a palustrine, forested, broad-leaved deciduous, temporarily flooded wetland. It lies within the 100-year FEMA-designated floodplain. Approximately 3 to 12 inches of water were observed standing within the channel at the time of the field visit. The channel was largely concrete-lined and contained within a culvert. The average OHWM was approximately 71.4 feet. An adjacent wetland (Wetland 1) was identified at Crossing 2 on the west side of US 183. Approximately 1 to 2 inches of standing water was observed in the wetland. Three Wetland Determination Data Forms (**WDP3, 4, 9**) were completed at the crossing. These forms are included in **Attachment C** and this crossing is shown on **Figure 6c**.

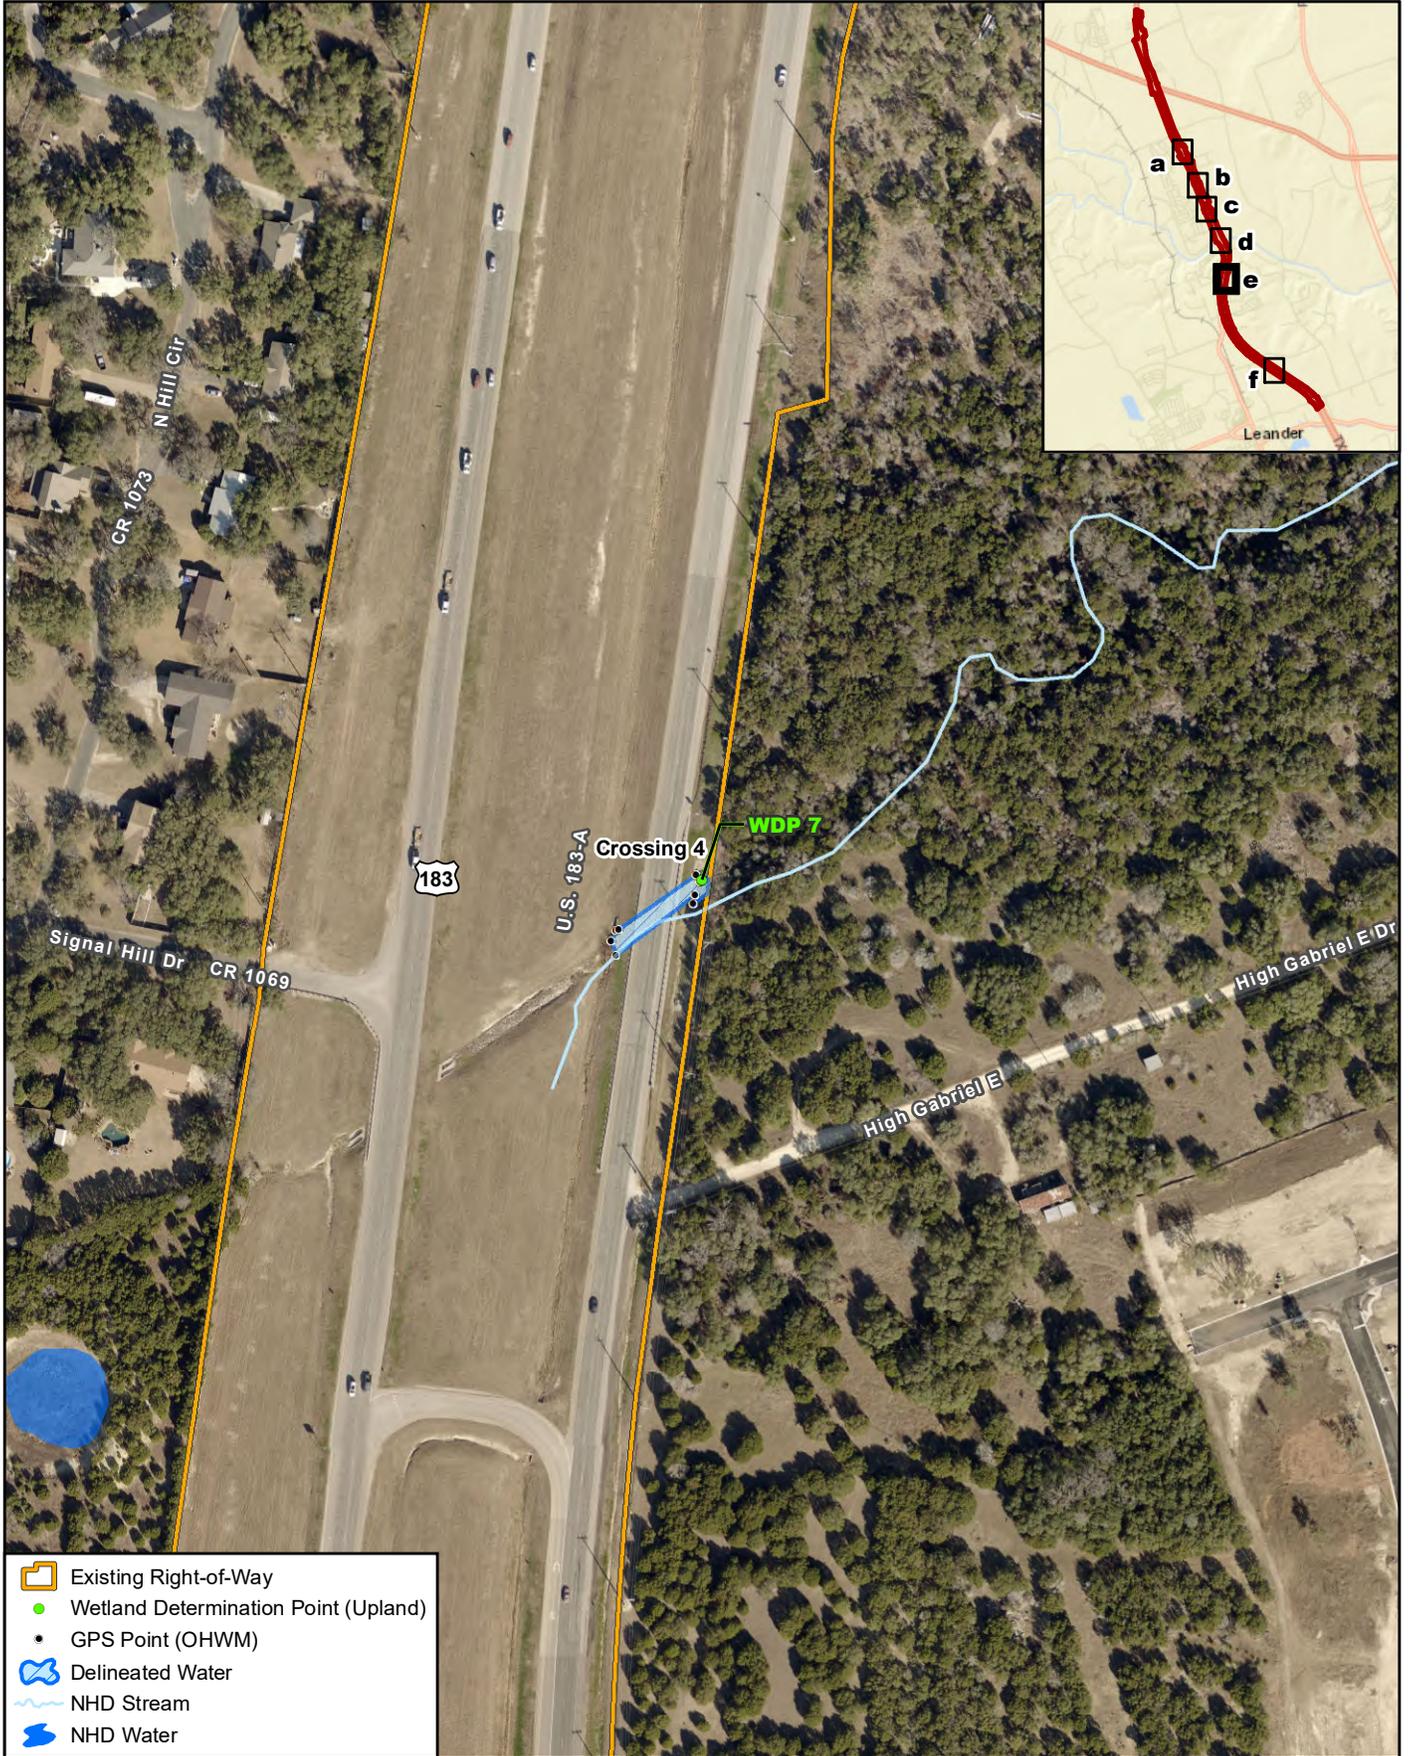
Figure 6e
Potential Waters of the U.S.
183A Phase III
